SYSX-65 : CBX CBV Continuous Restart issue

Issue Date: May 17th 2019
Product: CBX-8R8, CBX-8R8-H,
 CBV-2U4-3T, CBV-2U4-3T-N
Product Version: 7.9.1

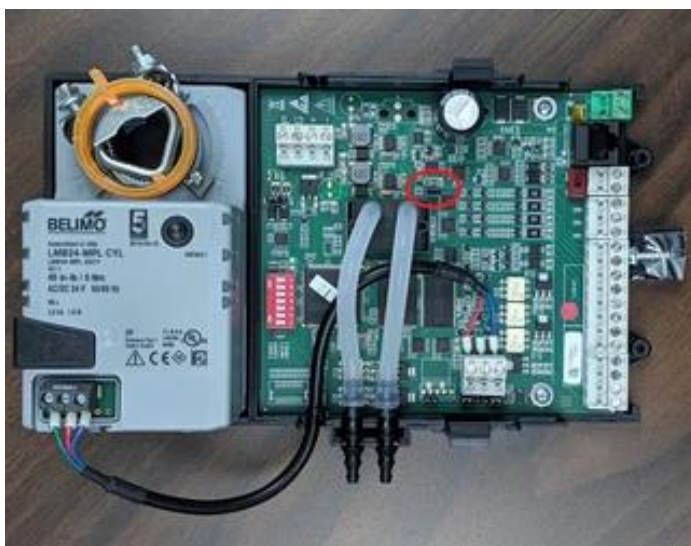
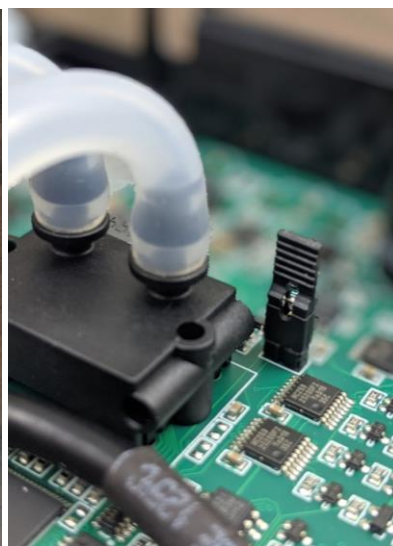
1. Remove the cover by pulling back on the finger tabs.
2. Place jumper over the jumper header next to the flow sensor (see images below.)

3. Wait for up to 3 minutes for the unit to resume normal operation
4. Upgrade the firmware to version 7.9.1 over the BACnet network
5. Remove the jumper on the header next to the flow sensor
6. Replace the cover

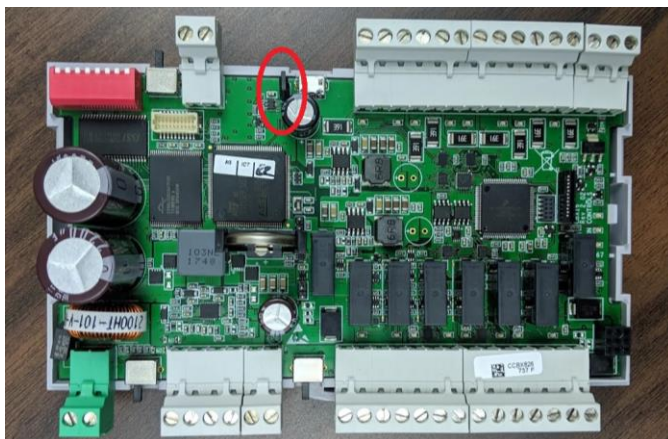
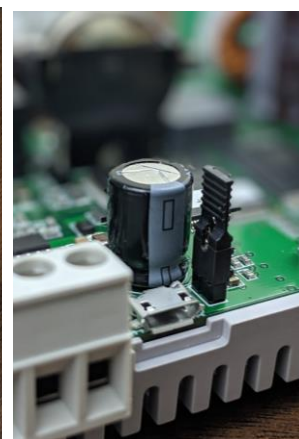
1. Remove the plastic lid by pulling back on the finger tabs.
2. Place a jumper over the jumper header next to the USB port:

3. Cycle Power in order to place the **CBX** into Bootloader mode
4. Attach **USB** cord to computer
5. Connect to the terminal interface by opening **Tera Term** (or equivalent) at any baud rate setting
