CYLON® TECHNICAL BULLETIN NO. 472

Issue Date: 01 November 2021

CXpro^{HD} v1.05

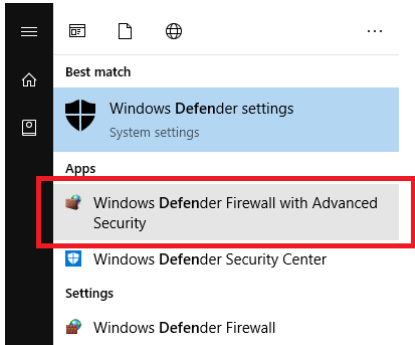
1. A specific Firewall setting has been reported to block broadcast BACnet packets, causing a situation where users must enter BBMD settings in CXpro^{HD} to allow communication when PC and devices are on the same local network. This setting can be disabled as follows:

- o Open Windows Defender Firewall with Advanced Security
